SUPERIOR COURT OF THE STATE OF WASHINGTON
IN AND FOR THE COUNTY OF SPOKANE

DECLARATORY JUDGMENT:
IS THE RIVER PARK SQUARE
PARKING GARAGE A PUBLIC
NUISANCE?

COMPLAINT TO ABATE
PUBLIC NUISANCE

12 **RIVER PARK SQUARE PARKING GARAGE**

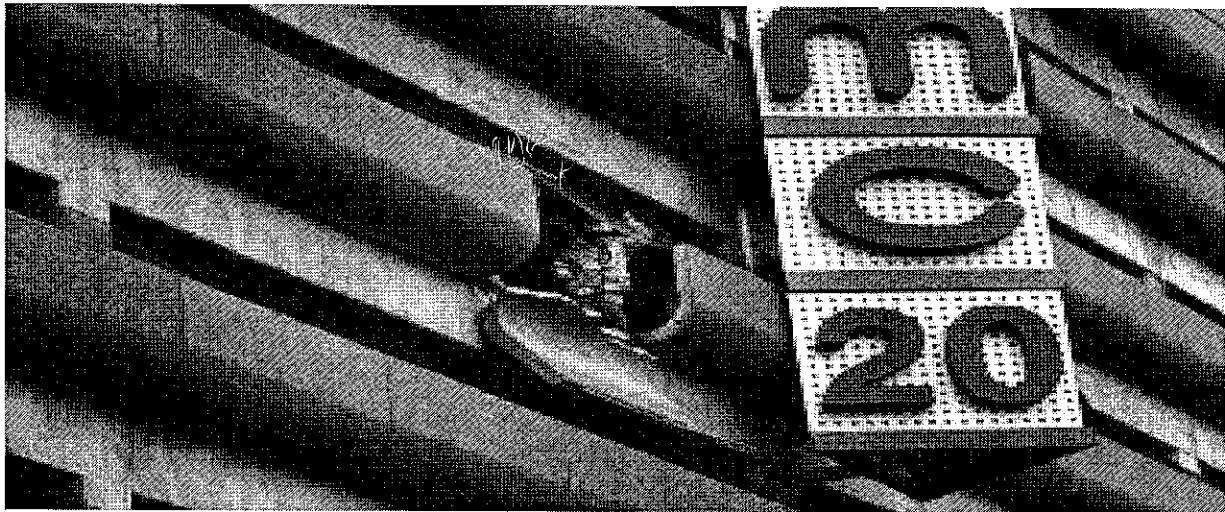
30 **Figure 1**

15
16 54. The spandrel broke and the upright part, the wall part, flipped outward and down.

31
32 55. The spandrel, broken, hung from the deck of the garage, the final failure prevented by
33 bent rebar holding the pieces of the spandrel together. Figure 1.

3 57. The figure shows a firefighter standing over the failed spandrel.
4

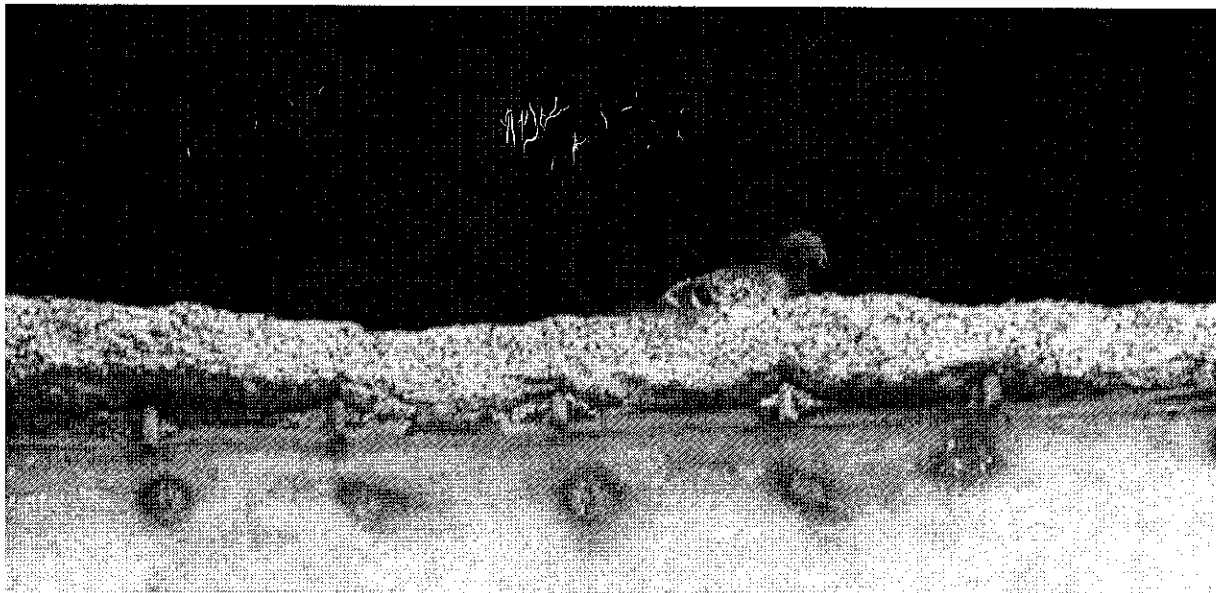
26 **Figure 2**

9 83. Look at Figure 2. This picture shows part of the failed spandrel which is still
10

27 attached to the parking deck of the garage. The picture was taken the night of May 1, 2006 by
28
29 the undersigned attorney for Plaintiff.

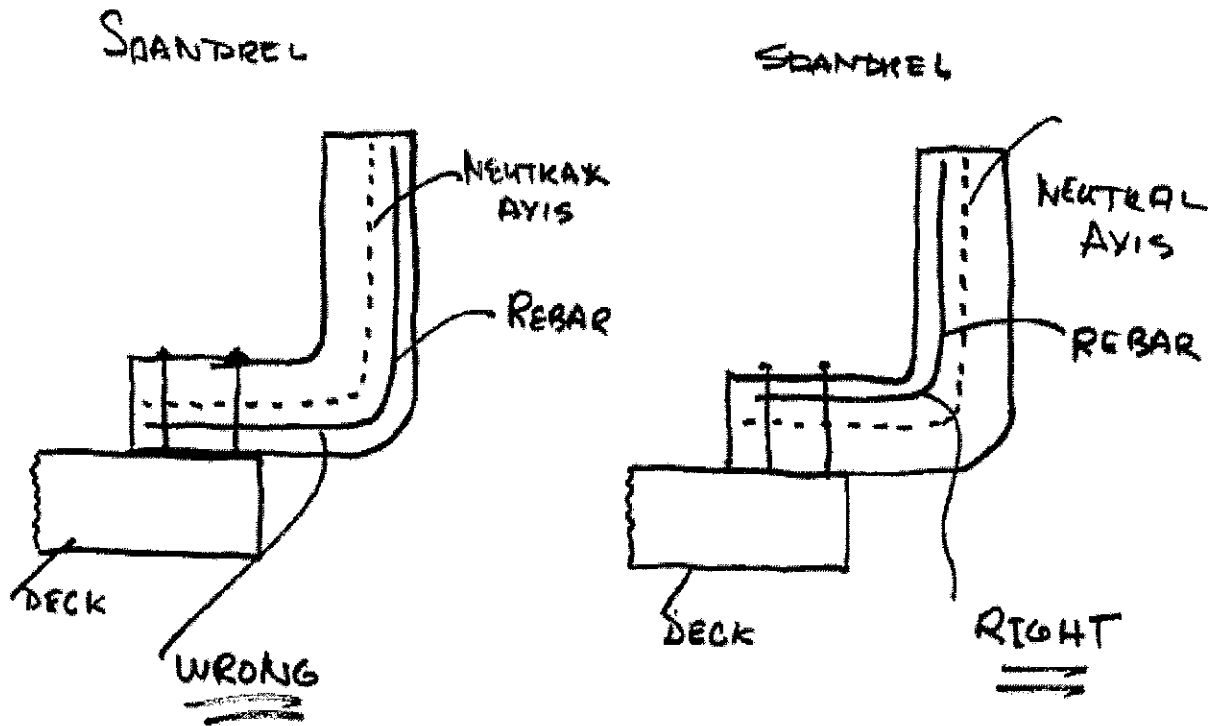
21 Figure 3

31
32 79. The rebar, as it appears from examination of the spandrel which failed, is located
33 between the outer edge of the spandrel – the edge facing out from the River Park Square Parking
34 Garage deck area – and the "neutral axis" of the spandrel. See Figure 3.

8 82. The rebar should have been located on the inside of the neutral axis of the spandrel.

34 85. Common sense shows that the rebar on the outside of the curved part of the spandrel
35
36 does nothing to prevent the spandrel from breaking on the inside of the curved part of the

1 spandrel as a result of force from a moving vehicle. See Figure 3.
2
3
4
